SUBJECT: Report on Project Assessment of the Bab Eshtar Substation 11 Kilo Volt (kV) Feeder Cable, Mosul, Iraq (Report Number SIGIR-PA-06-073)

**SIGIR PA-06-073**

# Bab Eshtar Substation 11 kV Feeder Cable Mosul, Iraq

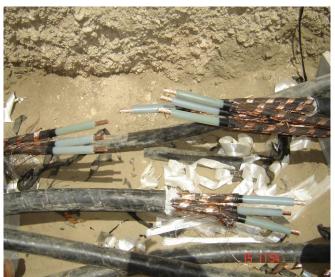
Cables were spliced together using a shrinkable splice kit for 3x150 mm<sup>2</sup>, 11kV, XLPE cable. This kit includes joining components and a shrinkable outer cover that tightened when heat was applied (Site Photos 6 and 7).

Site Photos 6 and 7. Cables spliced together with splice kit. Heat is applied to shrink outer cover. (Photo provided by contractor)

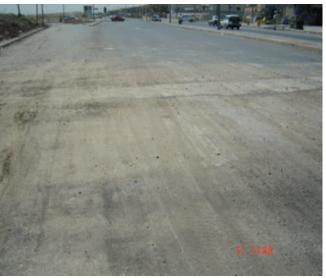
On main and secondary roads, a layer of concrete 15 cm thick was placed before being covered with 10 cm of asphalt to finish the roadway. The completed work was then cleaned of debris and work material (Site Photos 11 and 12).

Site Photos 11 and 12. Layer of concrete is placed before being covered with asphalt. Completed cleaned trench surface. (Photo provided by USACE)

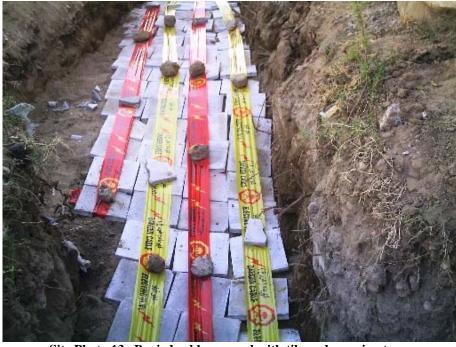
In addition, the assessment team found the photos included in both QC and QA reports descriptive and an effective supplement to the written reports. For example, a photo attached to the QC report dated 22 June 2006 shows that the buried cable was covered with concrete tile and warning tape as required by the SOW. A photo attached to the 1 July 2006 QA report was used to verify that materials complied with requirements. As such, the USACE PE stated that he was confident in the general reliability of the QC/QA systems employed to ensure effective QM and a good end product (Site Photos 13 and 14).

Site Photo 13. Buried cable covered with tile and warning tape.

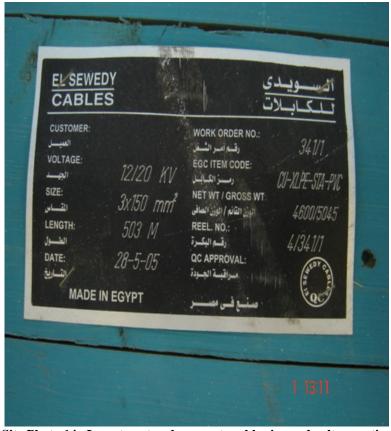
Site Photo 14. Inventory tag documents cable size and voltage rating.
